STATE OF MARYLAND
BOARD OF NATURAL RESOURCES
DEPARTMENT OF GEOLOGY, MINES AND WATER RESOURCES
JOSEPH T. SINGEWALD, JR., *Director*

BULLETIN 6
SHORE EROSION
IN
TIDEWATER MARYLAND

1949

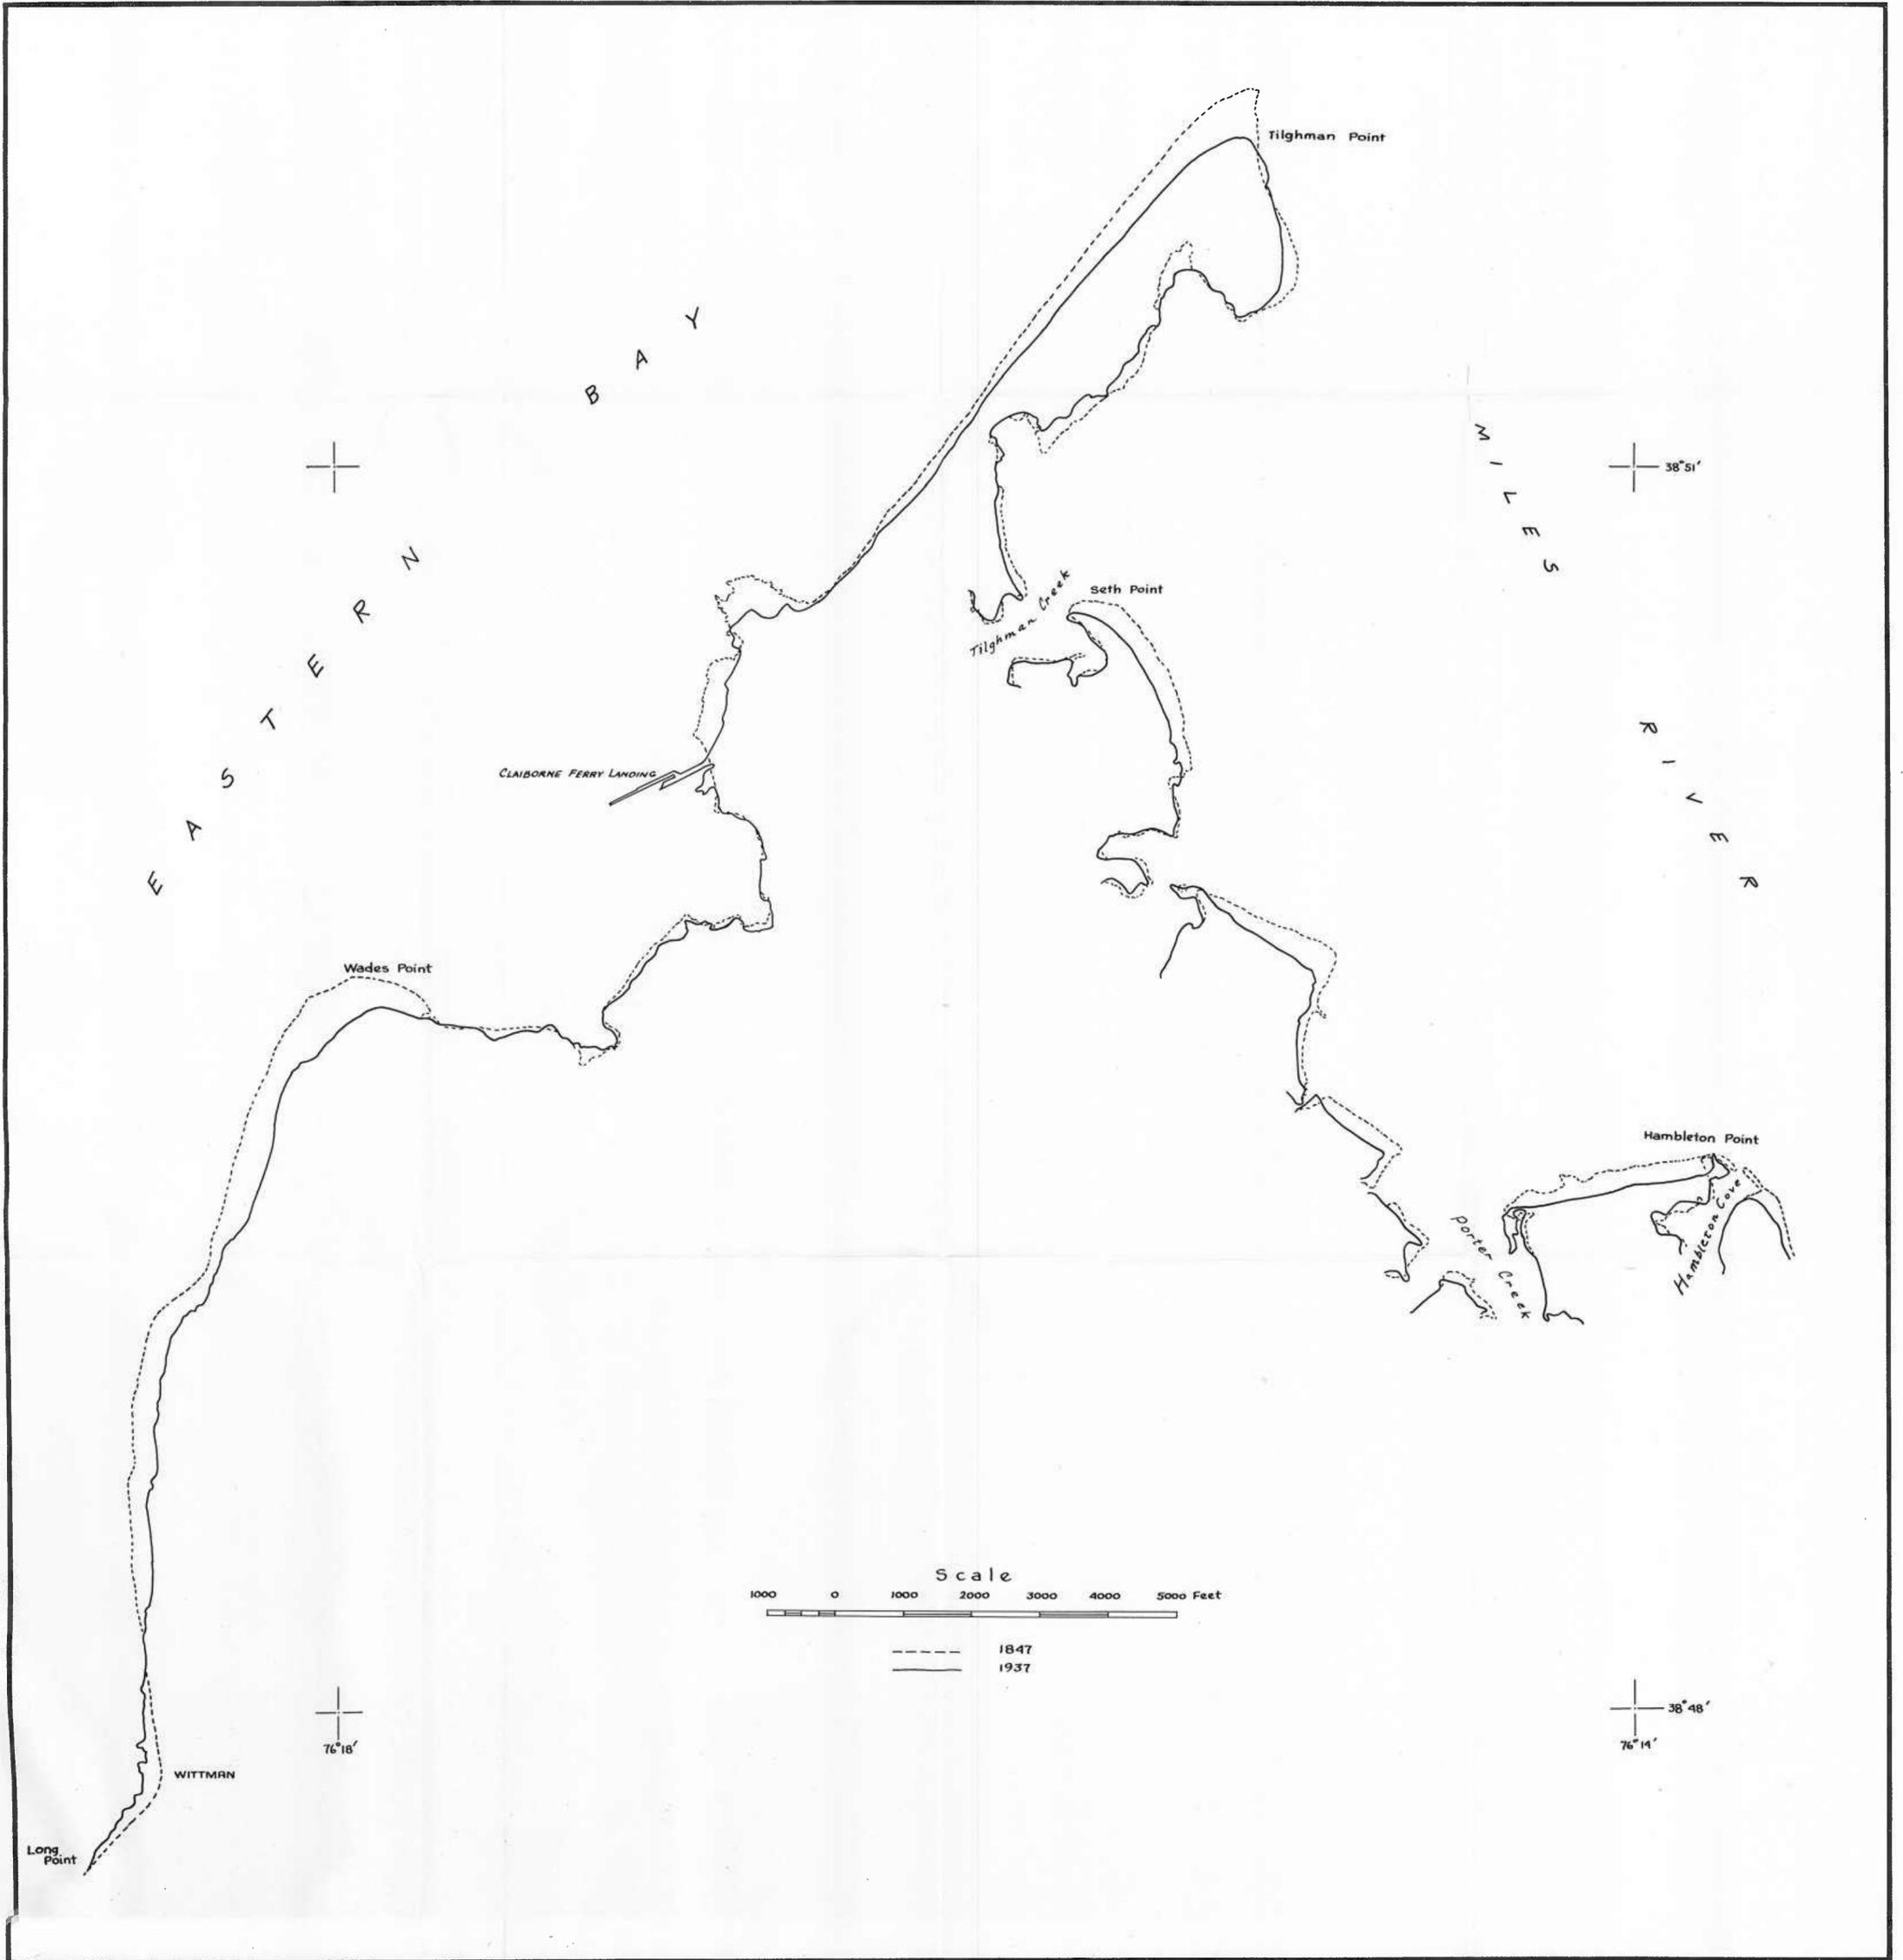
PLATE 24. Shore Line Changes from Hambleton Cove on Miles River to Long Point on Chesapeake Bay, Talbot County

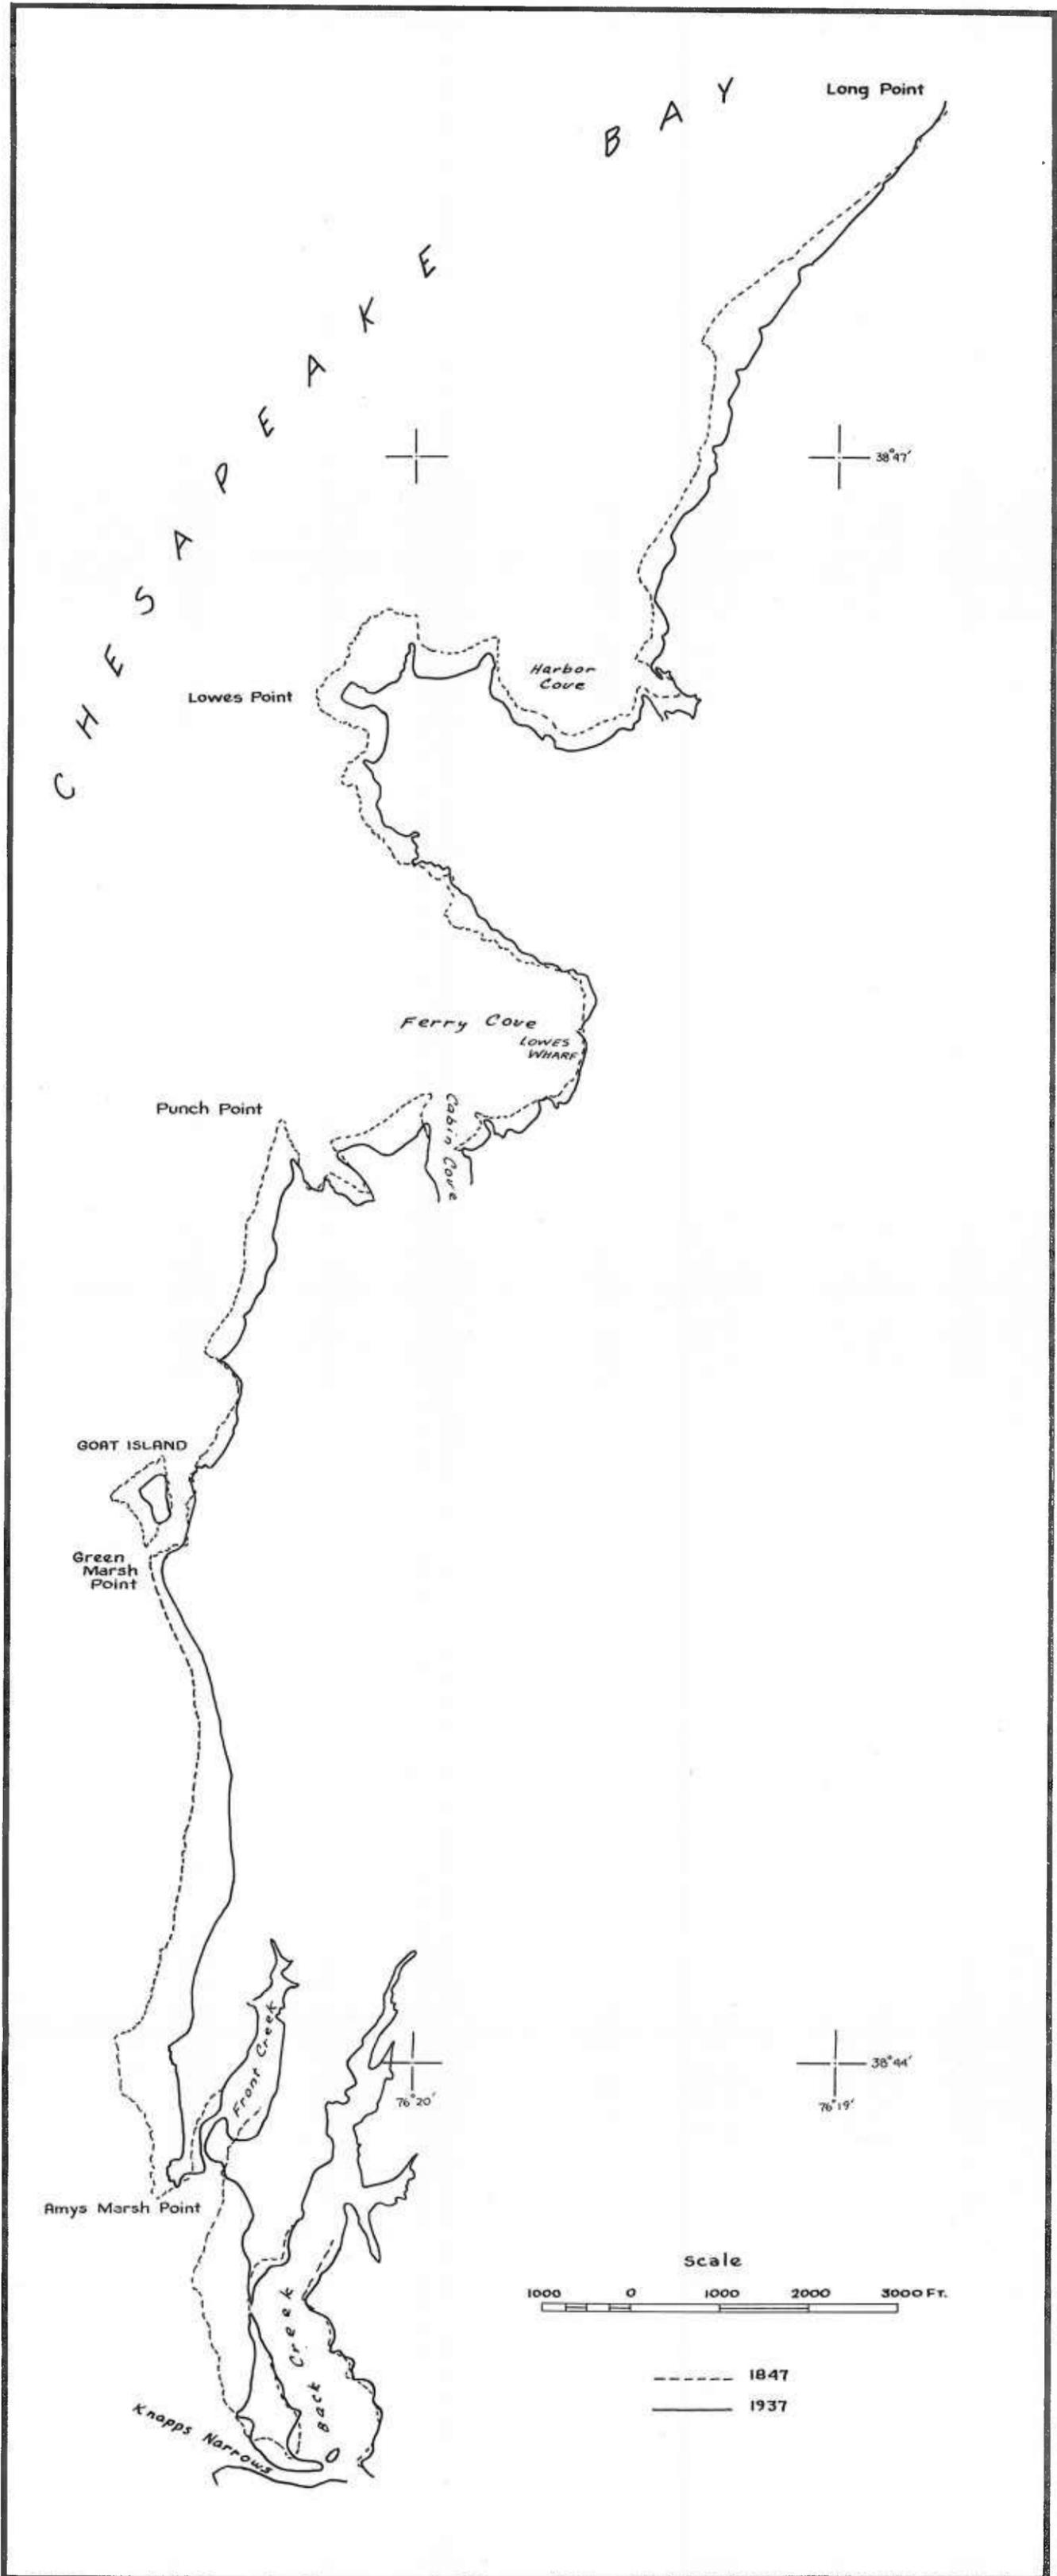
PLATE 25. Shore Line Changes from Long Point to Knapps Narrows, Chesapeake Bay, Talbot County

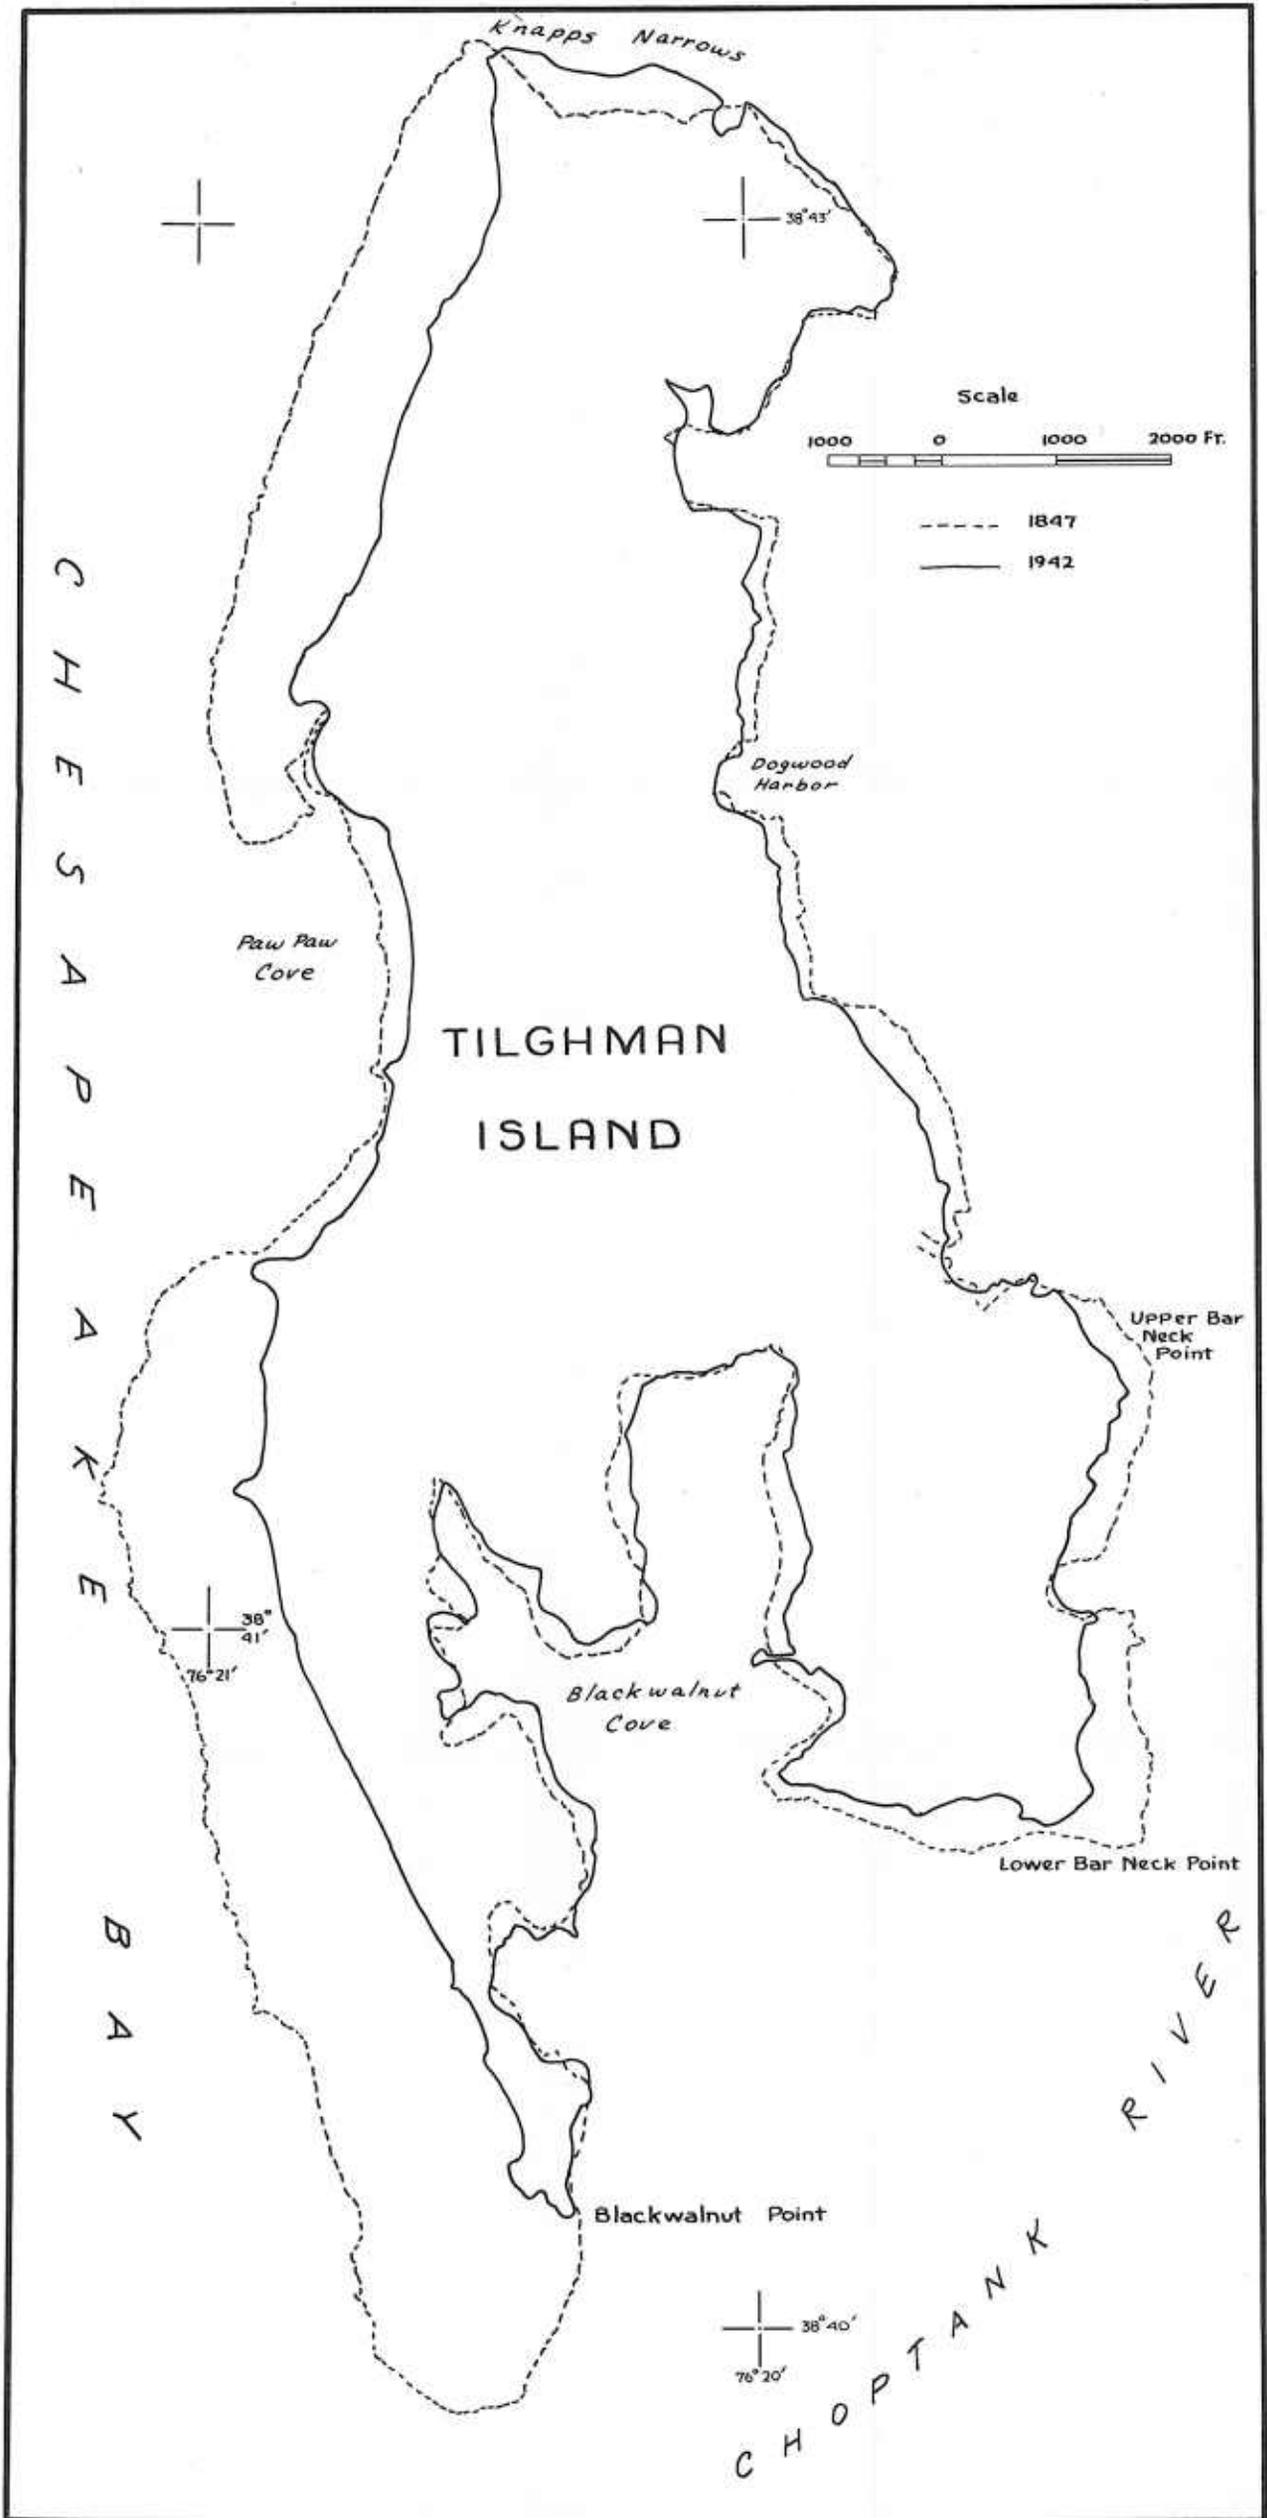
PLATE 26. Shore Line Changes on Tilghman Island, Talbot County

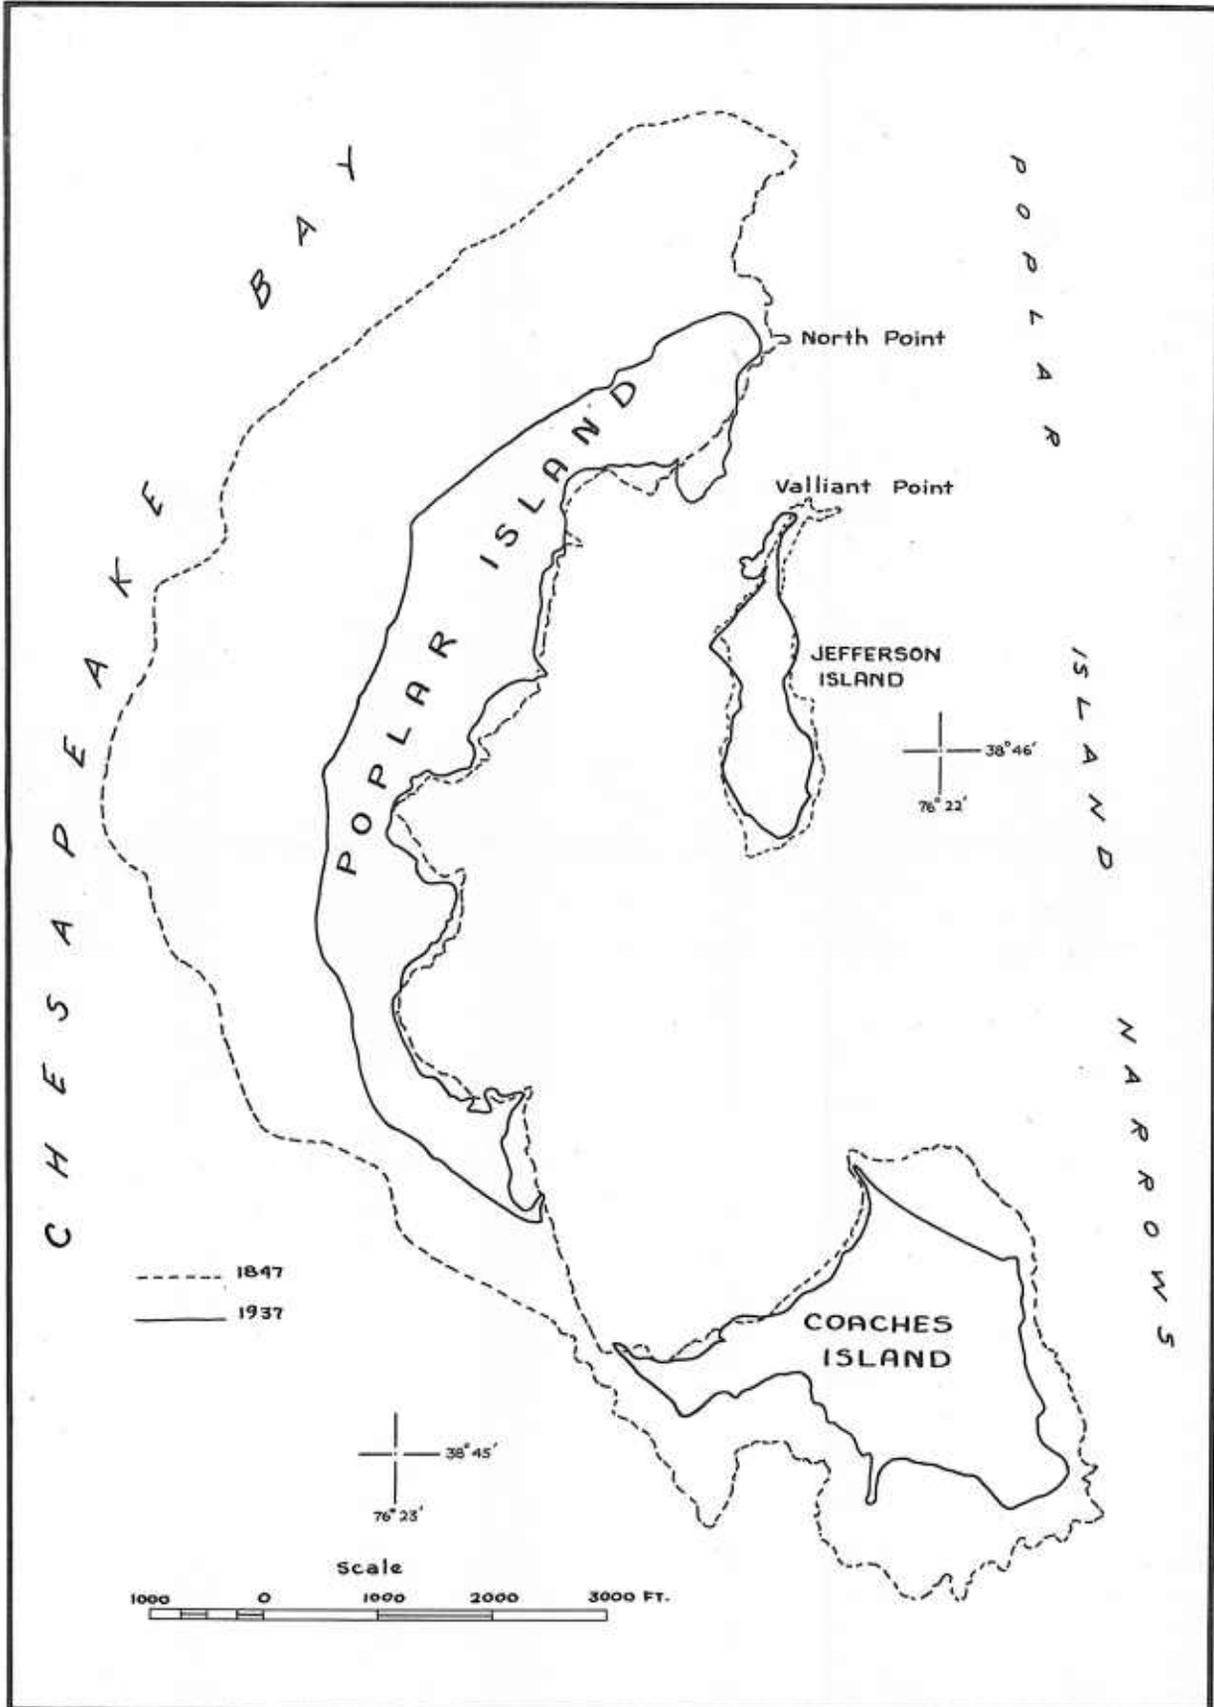
PLATE 27. Shore Line Changes on Poplar and Coaches Islands, Talbot County

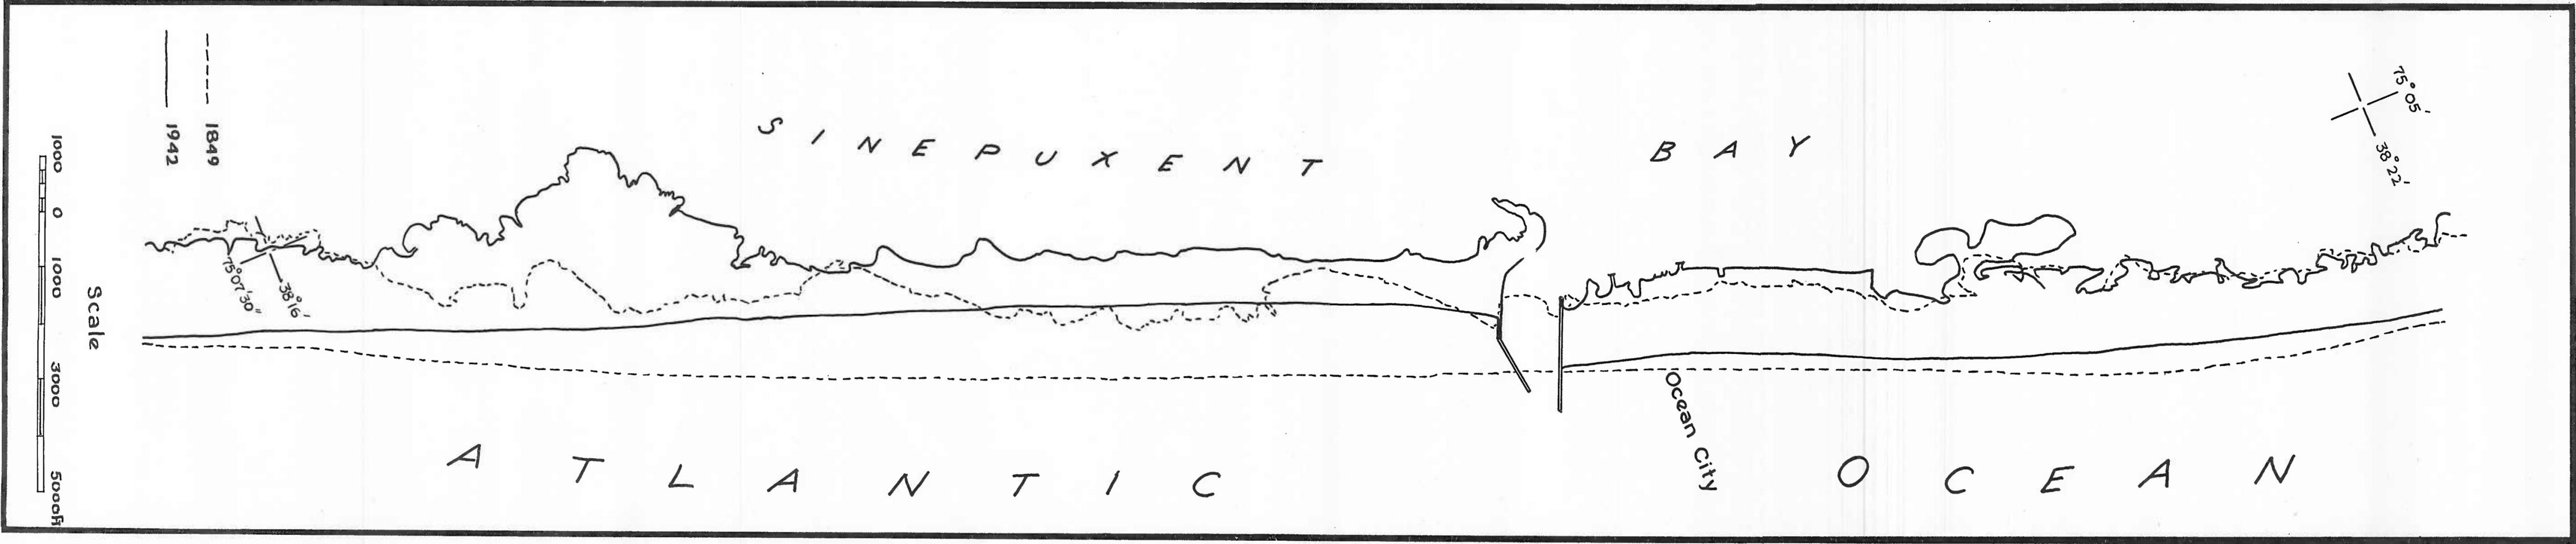
PLATE 28. Shore Line Changes on Fenwick Island and Assateague Island between Latitudes $38^{\circ}22'N$ and $38^{\circ}16'N$, Worcester County.
